## **UPGRADE OF CEMENT GRINDING LINE**

## INSTALATION OF 3<sup>RD</sup> GENERATION OF SEPARATOR

## **REHABILITATION OF CEMENT MILL NR.1**

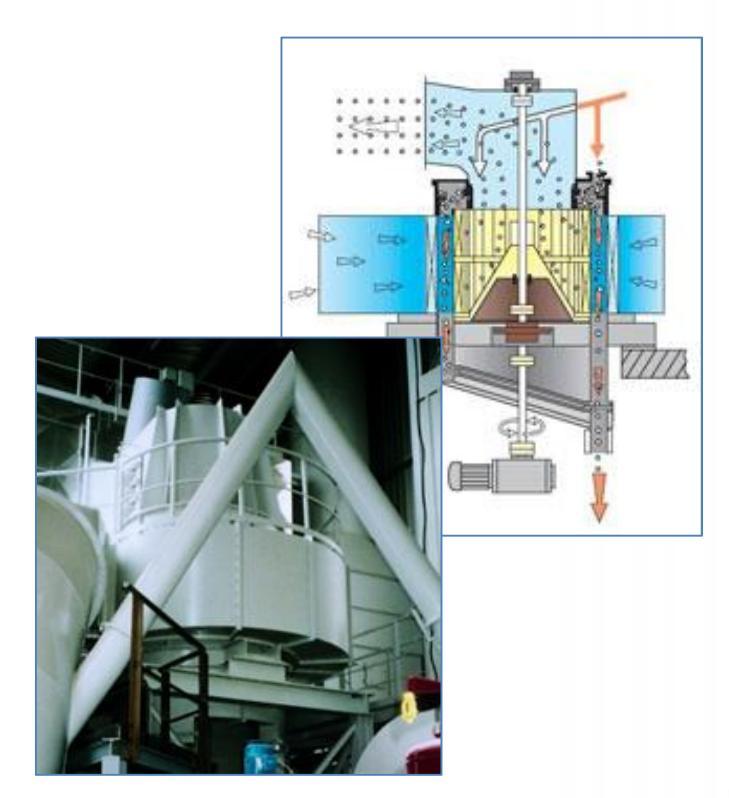
As a result of structural problems in the mill inlet (feeding screw), during 2012 the maintenance team of Sharrcem had to deal with numerous of stoppages of the Cement Mill Nr. 2.

For that reason the management decided to order new equipment for this part of the mill (which will be arrived at our plant by the middle of the year) in order to ensure the maximum availability of the mill.

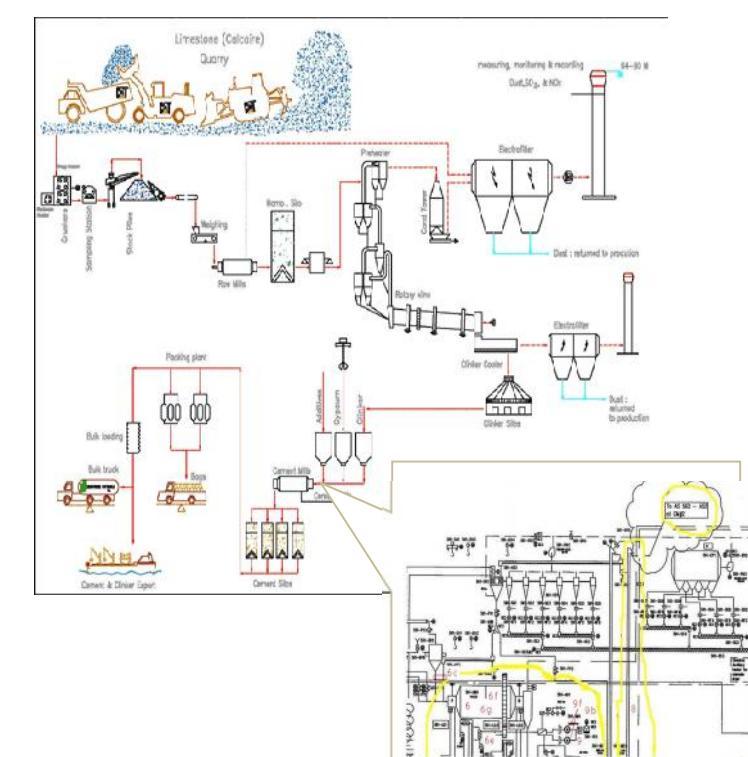
Cement mill 1 and 2 are "Twins". They were both manufactured in 1979 with the exact same capacity of 150 ton in OPC 42.5. After a 23 years of operation the management of that time decided to stop mill no. 1 and keep in operation only mill no 2. In the same time several of the spare parts required for mill no 2 were being dismounted from mill no 1.

For this reason the rehabilitation of mill no 1 had to embrace series of actions that started in the last Quarter of 2012 and will be completed by May 2013.

- Reconstructing the entering nozzle of the Clinker
- Installing new Weight feeder and transporter to the throat of the Cement Mill
- Inspecting of the Feeding screw, Pivot Shaft, CM shell.
- Installing the Main Motor of Gearbox
- Inspecting if needed fixing and replacing the damaged bearings on the main Gearbox
- Water Installation (including all the water pumps and pipes at CM1)
- Installation of high and low oil pressure pumps all around the CM1 line
- PLC programming
- Connecting the De-dusting Pipes form outside of CM1 to the Bag Filter of CM2
- Re constructing the Bucket elevator and connecting that with the Bucket elevator of CM2 through Air slide
- Installing new Air Slide from Separator to the throat of the Cement Mill
- Demolishing and removing completely the old Separator
